Mississippi Valley Conservation

*State of the Lake
Environment Report
December 2003*

Marble Lake

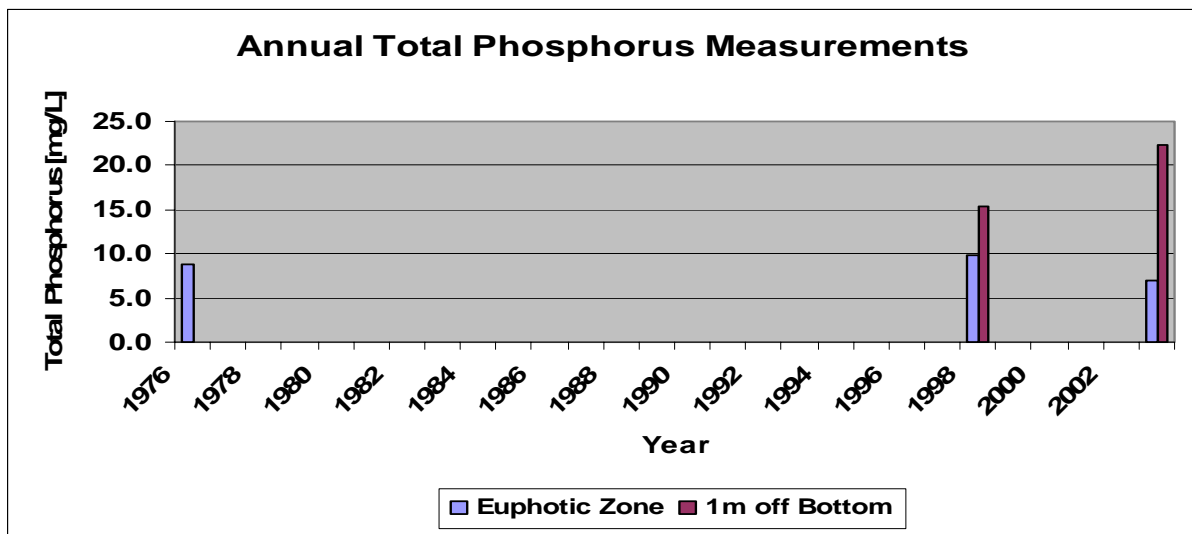
Interpreting Total Phosphorus Results:

Phosphorus is the nutrient that controls the growth of algae in most Ontario lakes. For this reason any increase in phosphorus in the lake will increase the quantity of algae that can grow. High levels of phosphorus can lead to algal blooms and in some cases affect the habitat of cold water fish such as lake trout. A general guideline exists to characterize your lake based on the total phosphorus that is measured.

INTERPRETING YOUR TOTAL PHOSPHORUS RESULTS	
Total Phosphorus	Lake Nutrient Status
10ug/L or less	Oligotrophic - unenriched, few nutrients
11 to 20ug/L	Mesotrophic – moderately enriched, some nutrients
21ug/L or more	Eutrophic – enriched, higher levels of nutrients

Directly related to water clarity is the amount of nutrients, in particular phosphorus, entering the lake. The Provincial Objective for phosphorus levels in cold water lakes is 20 micrograms per litre ($\mu\text{g/L}$). In 2003, the mean for the euphotic zone (depth at which sunlight can penetrate or two times the secchi disk depth) was $7.0 \mu\text{g/L}$. The mean for the samples taken one metre off the bottom was also $22.33 \mu\text{g/L}$. Five years ago, the average phosphorus level was $9.9 \mu\text{g/L}$ in the euphotic zone and $15.3 \mu\text{g/L}$ one metre off the bottom of the lake, both below the Provincial Objective. Marble Lake has slightly decreased its average phosphorus level in the euphotic zone while increasing one metre off the bottom.

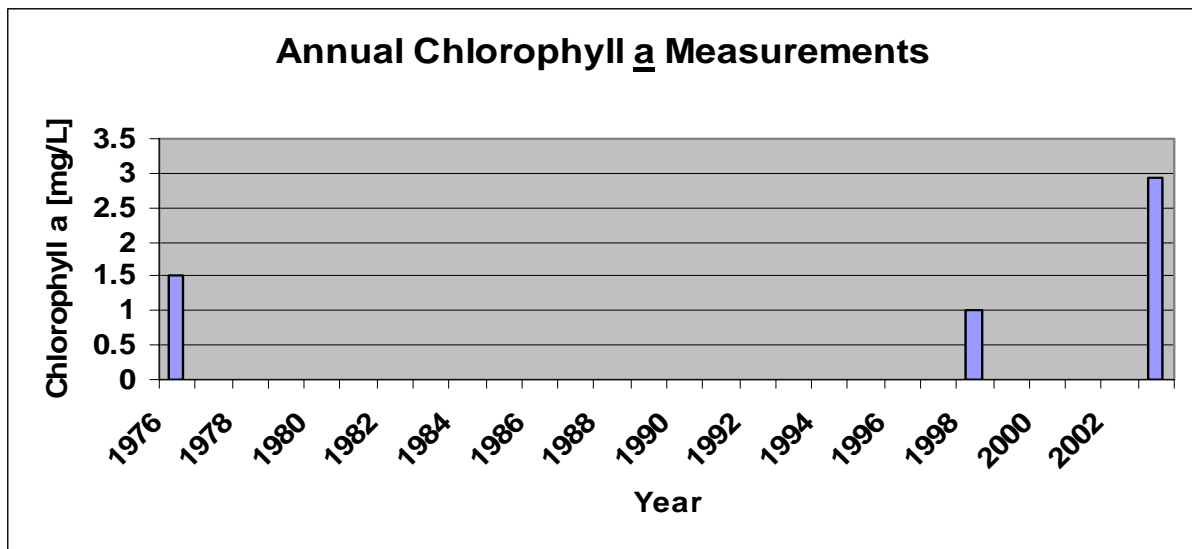
Evaluating your Chlorophyll a Results:

The lower the chlorophyll a density in your lake, the clearer your lake is. Chlorophyll a is directly affected by the amount of total phosphorus in your lake. The more phosphorus there is in the water, the more algal growth will occur.

INTERPRETING YOUR CHLOROPHYLL A RESULTS	
Secchi Reading	Lake Nutrient Status
Up to 2 ug/L - low algal density	Oligotrophic - unenriched, few nutrients
2-4 ug/L - moderate algal density	Mesotrophic - moderately enriched, some nutrients
More than 4 ug/L- high algal density	Eutrophic - enriched, higher levels of nutrients

Chlorophyll a is a measure of the algal density in the lake. The average chlorophyll a density for the sampling station was $2.93 \mu\text{g/L}$. Thus, indicating a moderate algal density for Marble Lake in 2003. In 1998, chlorophyll a levels were lower at $1.0 \mu\text{g/L}$. Thus indicating that Marble Lake is a moderately enriched (some nutrients) or mesotrophic lake.
