Mississippi Valley Conservation

*State of the Lake
Environment Report
December 2003
Marble Lake*

Marble Lake

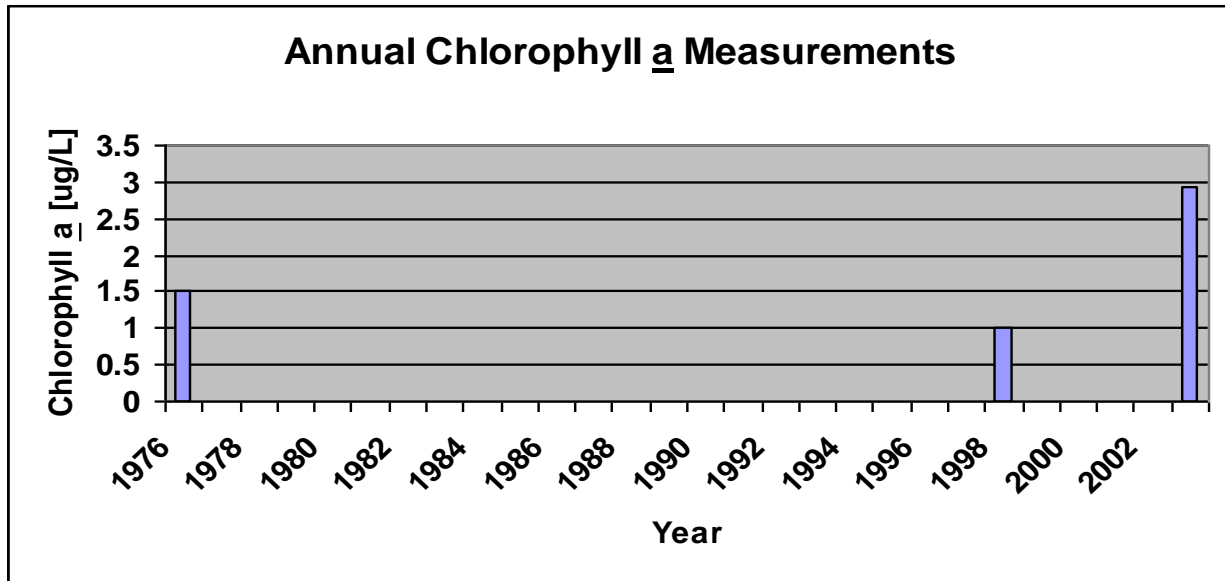
Evaluating your Chlorophyll a Results:

The lower the chlorophyll a density in your lake, the clearer your lake is. Chlorophyll a is directly affected by the amount of total phosphorus in your lake. The more phosphorus there is in the water, the more algal growth will occur.

INTERPRETING YOUR CHLOROPHYLL A RESULTS	
Chlorophyll <u>a</u> Reading	Lake Nutrient Status
Up to 2 ug/L - low algal density	Oligotrophic - unenriched, few nutrients
2-4 ug/L - moderate algal density	Mesotrophic - moderately enriched, some nutrients
More than 4 ug/L- high algal density	Eutrophic - enriched, higher levels of nutrients

Chlorophyll a is a measure of the algal density in the lake. The average chlorophyll a density for the sampling station was 2.93 $\mu\text{g/L}$. Thus, indicating a moderate algal density for Marble Lake in 2003. In 1998, chlorophyll a levels were lower at 1.0 $\mu\text{g/L}$. Thus indicating that Marble Lake is a moderately enriched (some nutrients) or mesotrophic lake.
