Mississippi Valley Conservation

*State of the Lake
Environment Report
2006*

Patterson Lake

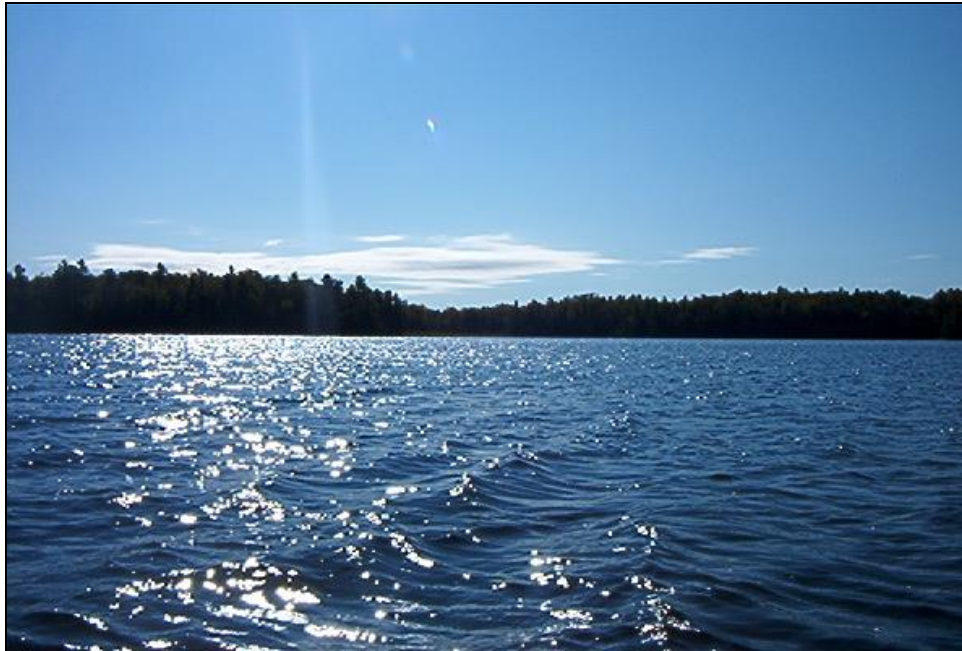
In general the water quality in Patterson Lake is good. There is one sampling station at the deepest point as indicated on the map included in this report. This station was sampled three times in 2006. Graphs will follow that show water clarity, as measured by Secchi Disc, observations were very good. The mean for 2006 is 5.0 metres indicating that Patterson Lake is an unenriched (few nutrients) or oligotrophic lake.
