Mississippi Valley Conservation

*State of the Lake  
Environment Report  
December 2004*

*Malcolm Lake*

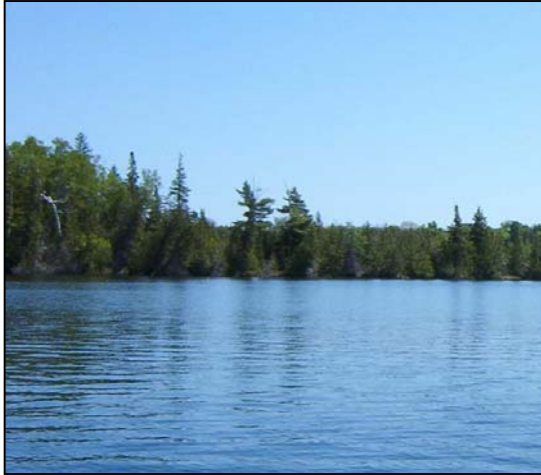
The dissolved oxygen and temperature data, measured at the deepest point in the main basin, indicate oxygen concentrations in the deep water portion remain adequate to support warm water fish species, such as smallmouth bass, throughout the ice-out season.

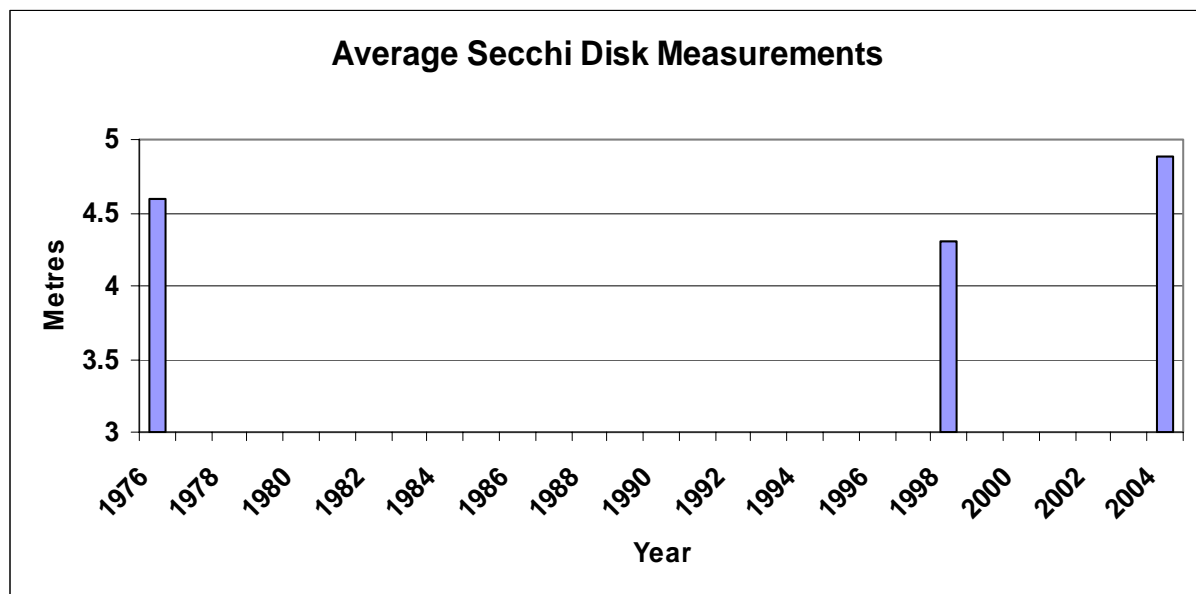
A Secchi disk is a black and white coloured disk used to determine water clarity. The disk is lowered into the water. The point, at which you can no longer distinguish the black and white, is called the Secchi depth.

**The higher the Secchi Disk measurement the clearer your lake is.**

INTERPRETING YOUR SECCHI DISC RESULTS	
Secchi Reading	Lake Nutrient Status
Over 5 metres	Oligotrophic - unenriched, few nutrients
3.0 to 4.9 metres	Mesotrophic – moderately enriched, some nutrients
Less than 2.9 metres	Eutrophic – enriched, higher levels of nutrients

In general, the water quality in Malcolm Lake remains good. There is one sampling station on the lake at the deepest point as indicated on the bathymetric map included in this report. You will find graphs which follow, that water clarity, as measured by Secchi Disk readings, were observed as good. The average for 2004 is 4.9 metres, thus indicating that Malcolm Lake is a moderately enriched (some nutrients) or mesotrophic lake, compared to 5 years ago, when the average was 4.3 metres.

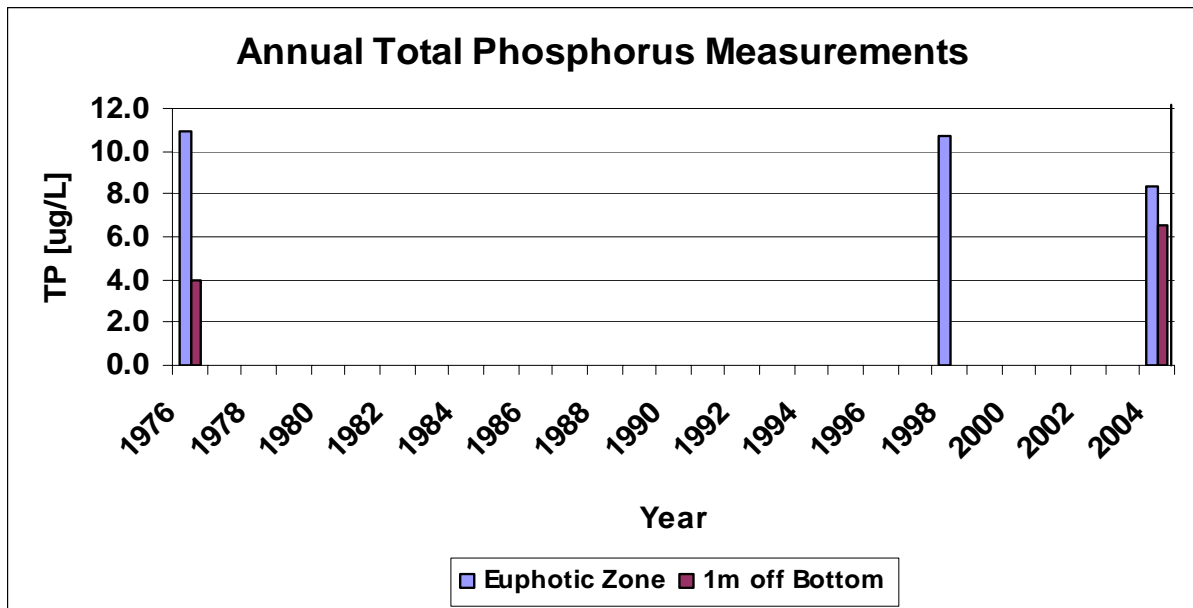
Phosphorus is the nutrient that controls the growth of algae in most Ontario lakes. For this reason any increase in phosphorus in the lake will increase the quantity of algae that can grow. High levels of phosphorus can lead to algal blooms and in some cases affect the habitat of cold water fish such as lake trout. A general guideline exists to characterize your lake based on the total phosphorus that is measured.

INTERPRETING YOUR TOTAL PHOSPHORUS RESULTS	
Total Phosphorus	Lake Nutrient Status
10 ug/L or less	Oligotrophic - unenriched, few nutrients
11 to 20 ug/L	Mesotrophic – moderately enriched, some nutrients
21 ug/L or more	Eutrophic – enriched, higher levels of nutrients

Directly related to water clarity is the amount of nutrients, in particular phosphorus, entering the lake. The Provincial Objective for phosphorus levels in warm water lakes is 20 micrograms per litre ( $ug/L$ ). In 2004, the mean for the euphotic zone (depth at which sunlight can penetrate or two times the secchi disk depth) was  $8.33 ug/L$ . The mean for the samples taken one metre off the bottom was  $6.5 ug/L$ , both readings are below the Provincial Objective. Five years ago, the average phosphorus level was  $10.7 ug/L$ . Therefore, Malcolm Lake has decreased its average phosphorus levels.

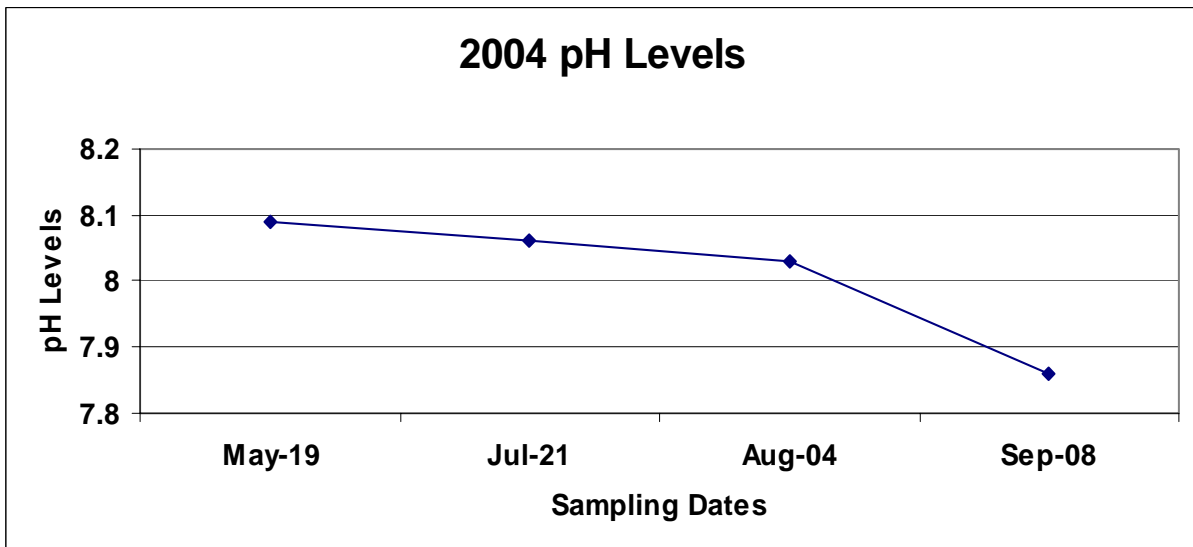
Lakes with pH levels at 7.3 or higher are vulnerable to zebra mussels invasive.
