*STATE OF THE LAKE  
Environment Report  
2013*

***MARBLE LAKE***

A lake monitoring program of the Mississippi Valley Conservation Authority

WATER QUALITY RESULTS (1976 - 2013) - MARBLE LAKE - MAIN BASIN

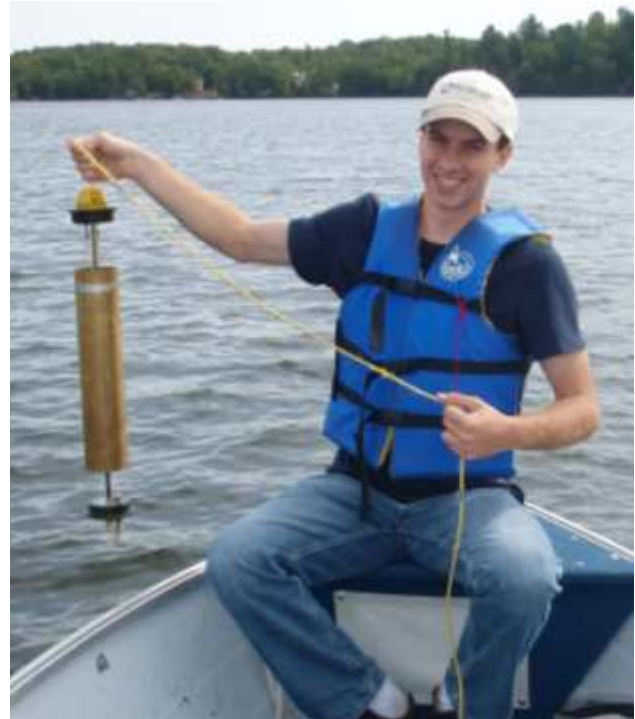
**A Kremmerer Bottle (pictured to the right) is used to sample water at specific depths. The bottle is lowered to the required depth with both ends open. A weight on the rope is dropped. When the weight hits the bottle it causes both ends to close, sealing the sample water in the bottle.**

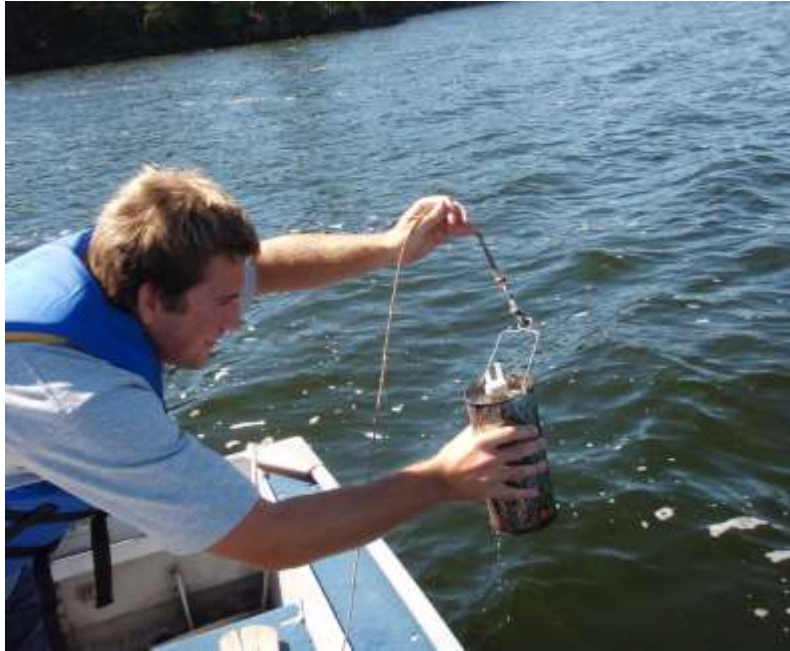
**A Composite Sampler (pictured above) is used by dropping the tin container into the water. When it reaches the required depth it is slowly pulled back to the surface. The tin is filled as water enters one tube and air escapes the other. Some air remains in the tin to ensure collection throughout the haul to the surface.**

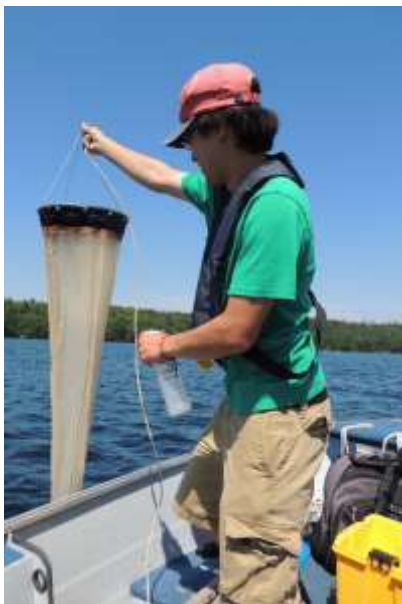
*The plankton haul net (pictured above) looks like a wind sock with a plastic cup attached to the end. The mesh size of the net is 63 microns, which can filter microscopic organisms (plankton) like spiny water flea and zebra mussel veligers from the water. The plastic cup portion of the net is called the cod end. It collects the plankton sample as water passes through the net.*

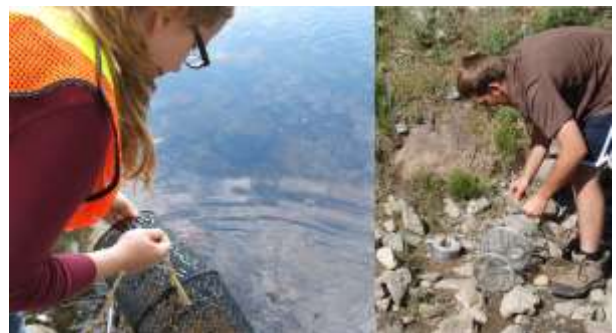
*Baited minnow traps (pictured right) with slightly widened openings on each end are used to sample for rusty crayfish. Traps are placed in shallow areas along the shoreline. Traps are left for a minimum of 24 hours. If crayfish are found in the sample, MVCA staff identify the species and release native crayfish back into the lake.*

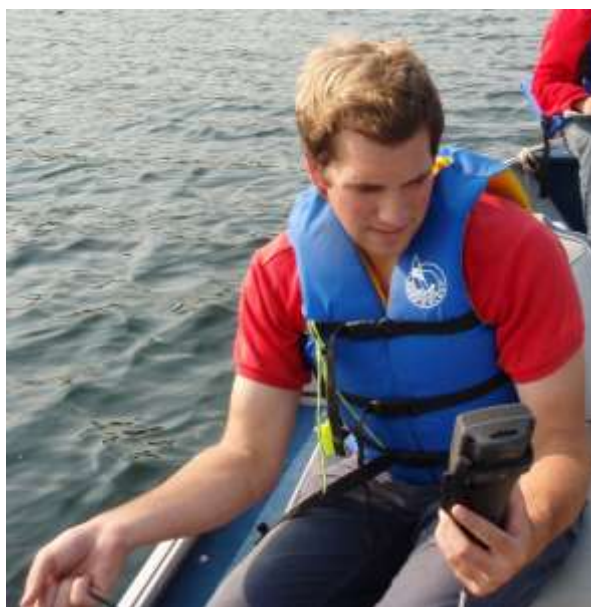
*The Dissolved Oxygen Metre is used to gather DO and temperature readings. The probe is lowered into the lake and readings are taken at every metre from the hand-held screen.*

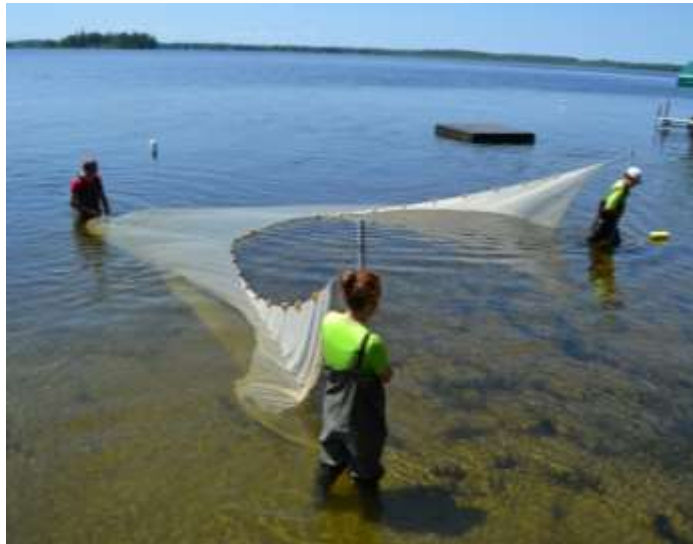
Seine netting by hand is a way of sampling fish species that may live or visit the near shore areas of a waterbody. A seine net is a type of fishing net that has floats along one edge and weights along the other edge, to keep it upright in the water. It is then dragged through a section of water, encircling it, thus collecting all the fish within that area. The depth of the testing area is limited to areas wadeable by the field crew. This method has a very limited impact on the health of the fish sampled and is affordable, easy to do, and portable.
